HomeSpec

Home Inspection Report

2345 Sample Street

Address: 2345 Sample Street, Anytown, CO 80525

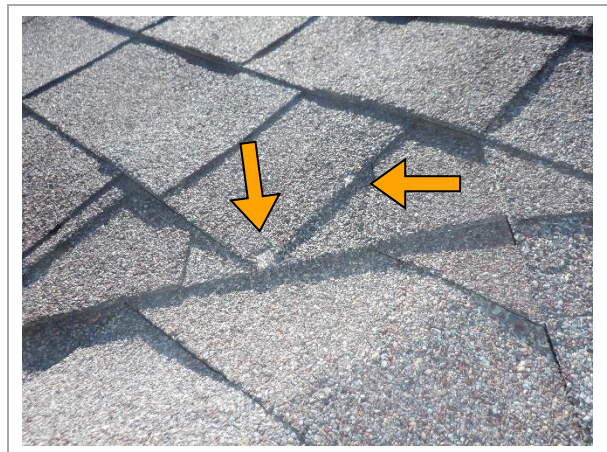
- Instances of minor shingle damage were noted in limited locations. Minor and limited instances of damage may result from normal wear and tear. Shingles in affected locations could experience diminished water shedding ability and a reduced service life.
- Leaves/debris in gutter system. Clogged gutters and gutter overflow can cause water damage to the adjacent eave/fascia materials and may contribute to foundation damage and flooding of basement areas. «

Figure 1.4 - Example instance minor shingle damage.

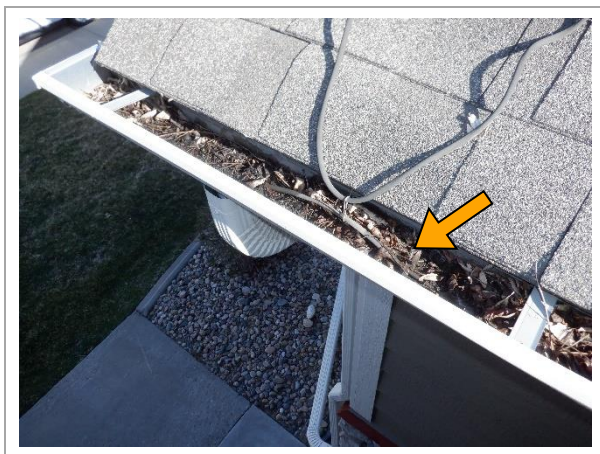
Figure 1.5 - Leaves/debris in gutter system.

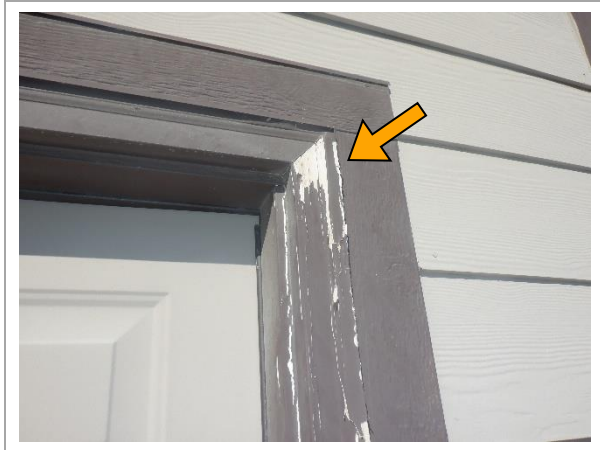
- Instances of paint/finish deterioration on exterior trim in some locations. Missing or degraded paint may contribute to deterioration of underlying materials.
- Exterior paint fading/chalking in some areas (particularly south facing). This could suggest that paint in the affected areas is in the latter stages of its expected service life.

Figure 2.1 – Example paint/finish deterioration.

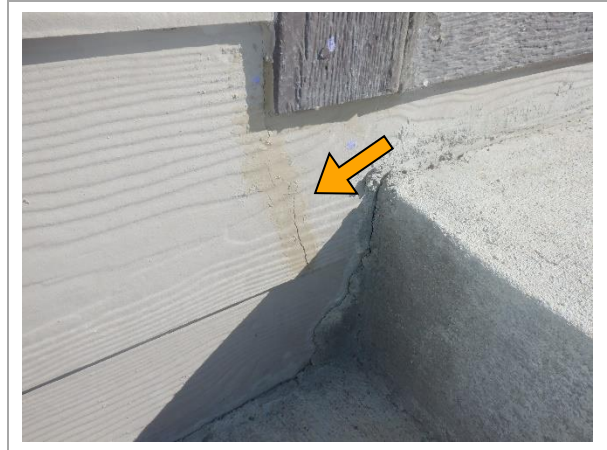
Figure 2.2 – Example cracked wall covering plank.

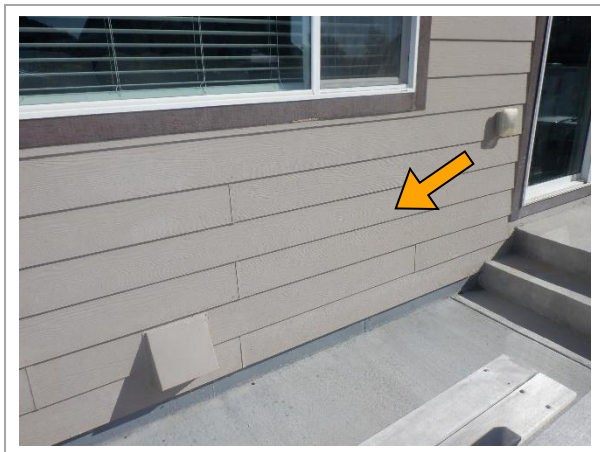
Figure 2.3 – Example area paint fading/chalking.

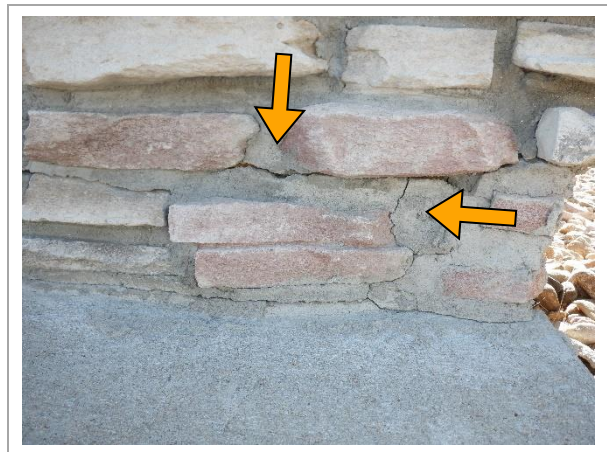
- Minor cracking on masonry wall coverings in limited locations. Gaps or openings may allow moisture/pest intrusion which can contribute to deterioration of underlying materials. «

Figure 2.4 – Example cracking on masonry wall covering.

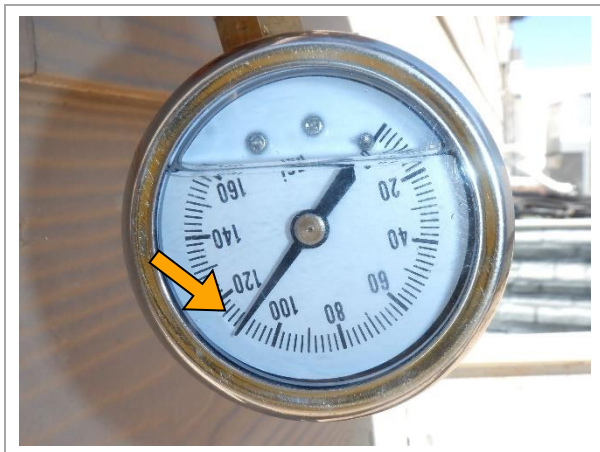
- Measured water pressure was noted to be above the expected range. Static water pressure (as measured at an exterior hose spigot) was approximately 110 psi. Most sources suggest that water pressure should not exceed 80 psi. Excessive pressure may lead to accelerated deterioration of plumbing components and appliances.
- Loose toilet base at main floor bathroom. Loose toilets may have hidden leaks in the area where the toilet meets the floor. This can lead to contamination and moisture damage in the surrounding subfloor and may allow sewer gasses/odors to enter the living space. «

Figure 6.9 – Water pressure noted to be above the expected range.

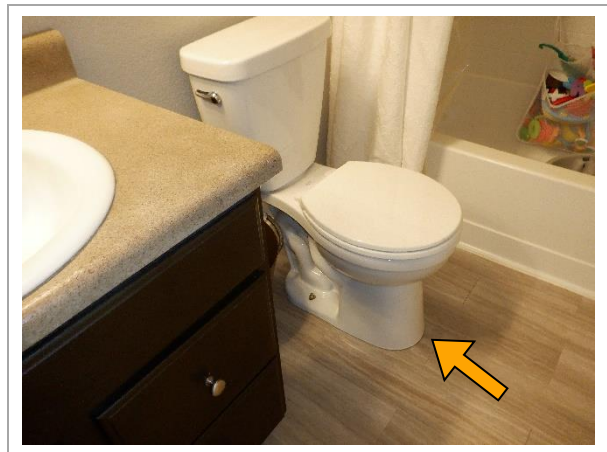
Figure 6.10 - Loose toilet base at main floor bathroom.

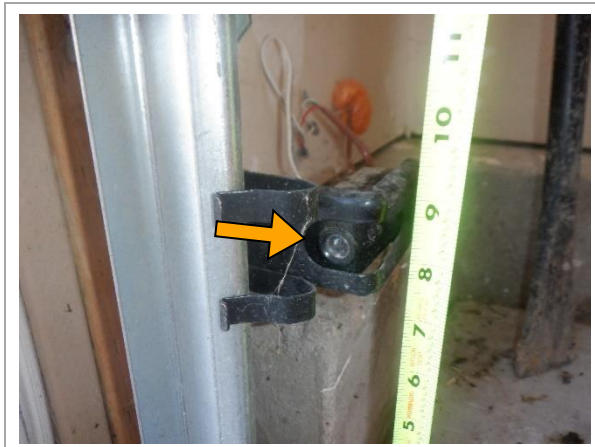
- Garage door photo sensors higher than 6 inches above the floor. Photo sensors that are too high above the floor may fail to sense a person or object within the door opening and could lead to property damage or injury. «

Figure 10.3 - Garage door photo sensors higher than 6 inches above the floor.

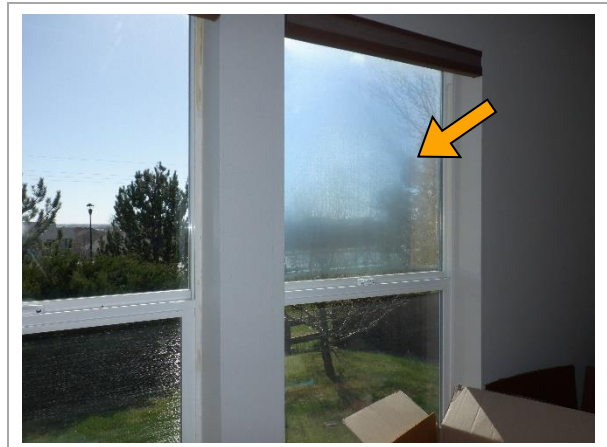
- Fogging or staining between glass panes at dining area. Staining or moisture between glass panes may indicate that internal window seals have failed resulting in visual deterioration and a possible reduction in energy efficiency.
- East garage door drags against its frame. Adjustment or repair may be needed. «

Figure 10.4 - Fogging or staining between glass panes at dining area.

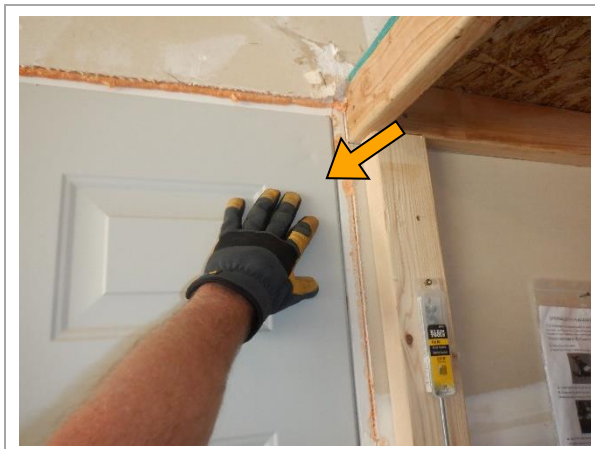
Figure 10.5 - East garage door drags against its frame.
